**ADDENDUM NUMBER 3**

**PROJECT: NORTHEAST GEORGIA REGIONAL COMMISSION RENOVATION  
ATHENS, GA  
GMC PROJECT NO. AATL250009**

# Asbestos Inspection Report

# Asbestos-Containing Material Field Inspection Report

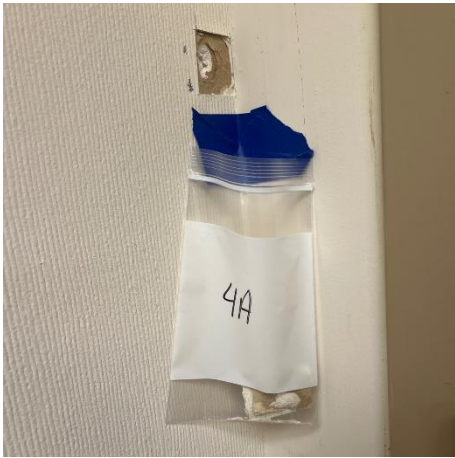
| <b>Sample ID</b> | <b>Material</b> | <b>Material Description</b> | <b>Location</b> | <b>% Asbestos</b> |
|---|---|---|---|---|
| <b>4A</b> | <b>Wall System (Joint Compound)</b> | <b>White</b> | <b>Meeting Room Connected to Printing Area</b> | <b>2% Chrysotile</b> |

4A, Wall System, Meeting Room Connected to Printing Area

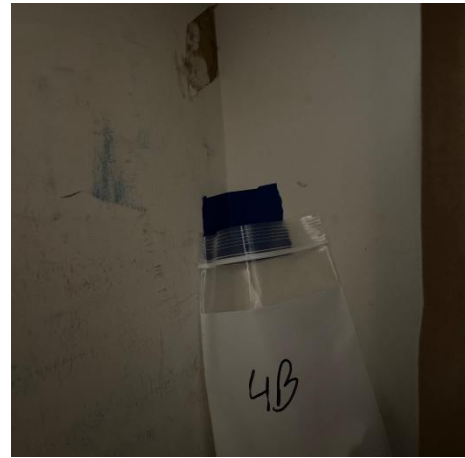
| <b>Sample ID</b> | <b>Material</b> | <b>Material Description</b> | <b>Location</b> | <b>% Asbestos</b> |
|---|---|---|---|---|
| <b>4B</b> | <b>Wall System (Joint Compound)</b> | <b>White</b> | <b>Back Hallway Office Supply Closet</b> | <b>2% Chrysotile</b> |

4B, Wall System, Back Hallway Office Supply Closet

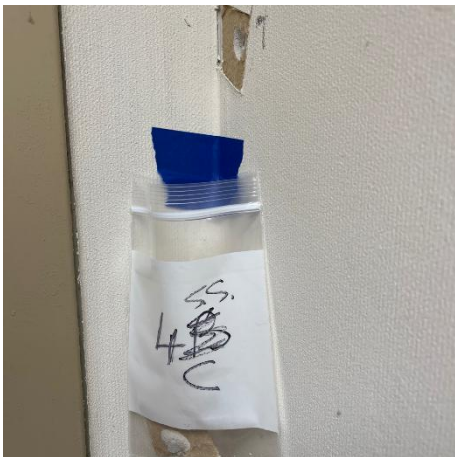
| <b>Sample ID</b> | <b>Material</b> | <b>Material Description</b> | <b>Location</b> | <b>% Asbestos</b> |
|---|---|---|---|---|
| <b>4C</b> | <b>Wall System (Joint Compound)</b> | <b>White</b> | <b>Wheelchair Storage</b> | <b>2% Chrysotile</b> |

4C, Wall System, Wheelchair Storage

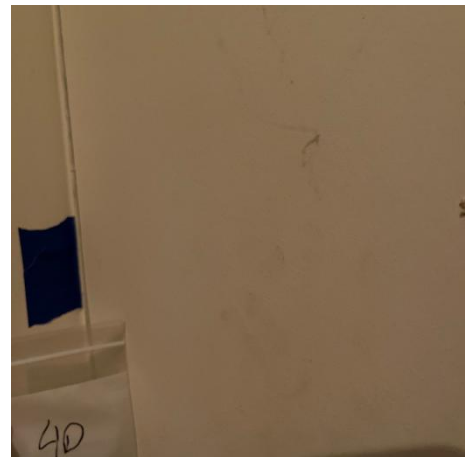
| <b>Sample ID</b> | <b>Material</b> | <b>Material Description</b> | <b>Location</b> | <b>% Asbestos</b> |
|---|---|---|---|---|
| <b>4D</b> | <b>Wall System (Joint Compound)</b> | <b>White</b> | <b>Water Heater Room</b> | <b>2% Chrysotile</b> |

4D, Wall System, Water Heater Room

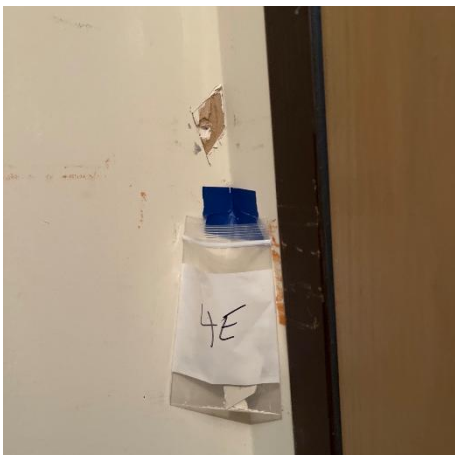
| <b>Sample ID</b> | <b>Material</b> | <b>Material Description</b> | <b>Location</b> | <b>% Asbestos</b> |
|---|---|---|---|---|
| <b>4E</b> | <b>Wall System (Joint Compound)</b> | <b>White</b> | <b>Electrical Room</b> | <b>2% Chrysotile</b> |

4E, Wall System, Electrical Room

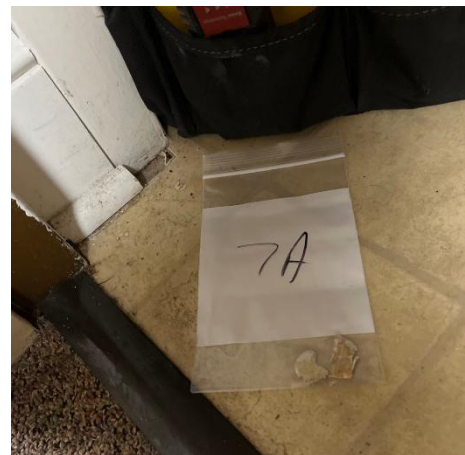
| <b>Sample ID</b> | <b>Material</b> | <b>Material Description</b> | <b>Location</b> | <b>% Asbestos</b> |
|---|---|---|---|---|
| <b>7A</b> | <b>Resilient Floor Covering</b> | <b>Beige- Third Layer</b> | <b>Center Hall Men's Bathroom</b> | <b>50% Chrysotile</b> |

7A, Resilient Floor Covering, Center Hall Men's Bathroom

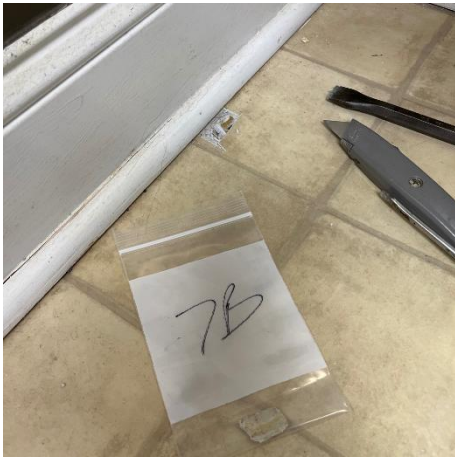
| <b>Sample ID</b> | <b>Material</b> | <b>Material Description</b> | <b>Location</b> | <b>% Asbestos</b> |
|---|---|---|---|---|
| <b>7B</b> | <b>Resilient Floor Covering</b> | <b>Beige- Third Layer</b> | <b>Center Hall Men's Bathroom</b> | <b>50% Chrysotile</b> |

7B, Resilient Floor Covering, Center Hall Men's Bathroom

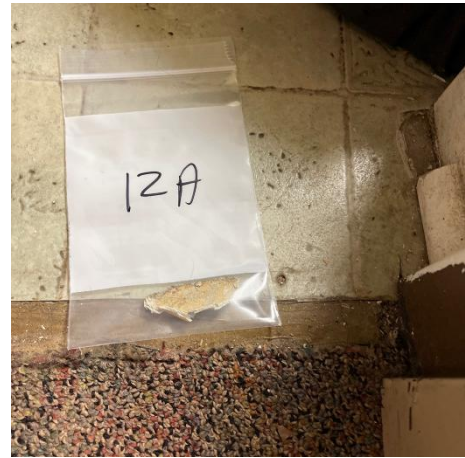
| Sample ID | Material | Material Description | Location | % Asbestos |
|---|---|---|---|---|
| <b>12A</b> | <b>Resilient Floor Covering</b> | <b>Tan- Third Layer</b> | <b>Women's Restroom</b> | <b>50% Chrysotile</b> |

12A, Resilient Floor Covering, Women's Restroom

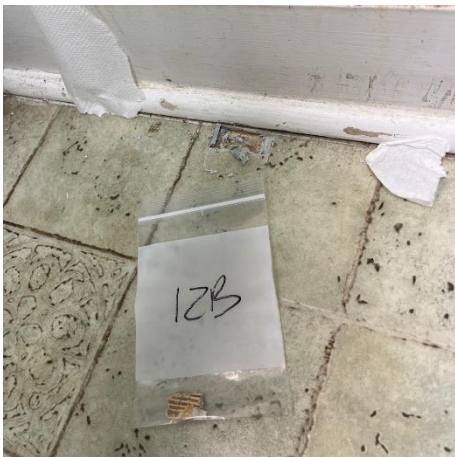
| Sample ID | Material | Material Description | Location | % Asbestos |
|---|---|---|---|---|
| <b>12B</b> | <b>Resilient Floor Covering</b> | <b>Tan- Third Layer</b> | <b>Women's Restroom</b> | <b>50% Chrysotile</b> |

12B, Resilient Floor Covering, Women's Restroom

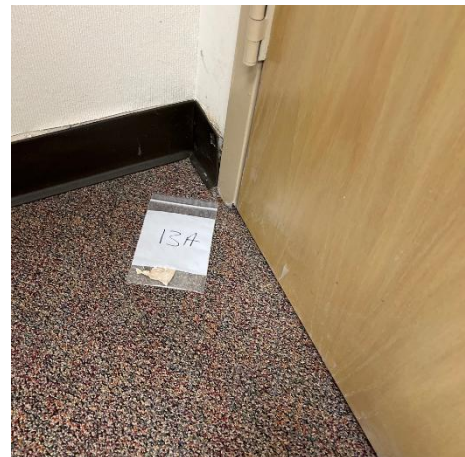
| Sample ID | Material | Material Description | Location | % Asbestos |
|---|---|---|---|---|
| <b>13A</b> | <b>Cove Base Adhesive (Joint Compound)</b> | <b>Brown</b> | <b>Meeting Room Connected to Printing Area</b> | <b>2% Chrysotile</b> |

13A, Cove Base Adhesive, Meeting Room Connected to Printing Area

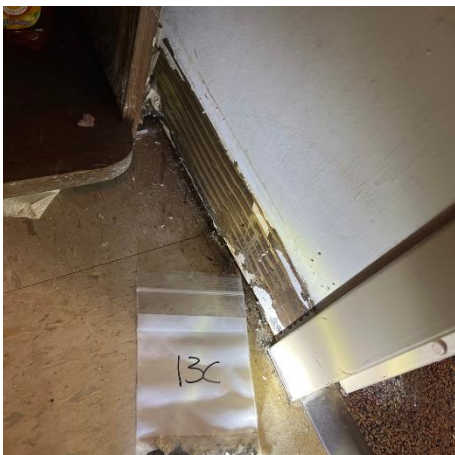
| Sample ID | Material | Material Description | Location | % Asbestos |
|---|---|---|---|---|
| <b>13C</b> | <b>Cove Base Adhesive (Joint Compound)</b> | <b>Brown</b> | <b>Water Heater Room</b> | <b>2% Chrysotile</b> |

13C, Cove Base Adhesive, Water Heater Room
